Sponsor Site Walk Log

Cactus Ridge Shops

Field notes, contractor comments and reserve sizing... Walk-through packet | Photo refs R-04/P-11/M-0...

FIELD PHOTO LOG / OPINION OF PROBABLE COST WORKSHEET

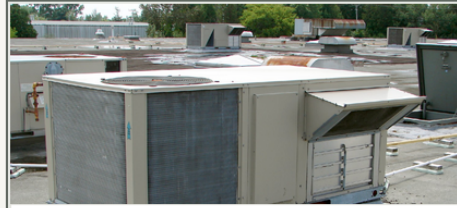
P-08 rooftop HVAC condition

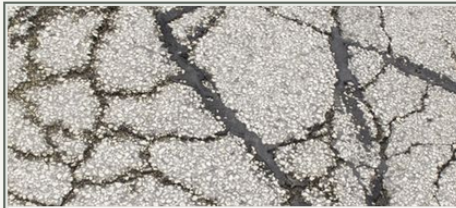
P-14 parking asphalt cracking

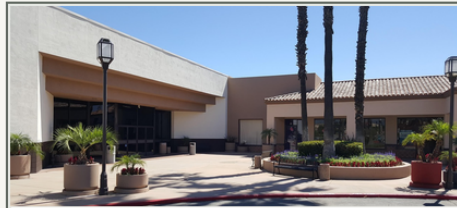
P-19 storefront / signage condition
