Vector Property Advisors Property Condition Assessment

Cactus Ridge Shops

PCA summary / ASTM E2018 property condition revi... Draft issued for lender review | Photo log referen...

ASTM E2018 Physical Condition Summary

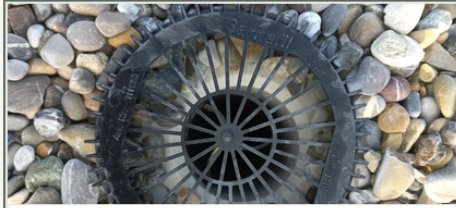
P-03 roof drain / ponding check

Photo Ref	System	Raw Observation	Consultant Follow-Up
P-03	Roof	patched membrane at scupper; ponding stain visible but dry during visit	Ask seller for roof warranty and leak log
P-08	HVAC	tenant unit tags mixed, several unreadable from grade	Collect maintenance schedule
P-14	Paving	alligator cracking at truck apron; not included in seller budget	Contractor scope before PSA waiver
P-19	Life Safety	extinguisher tags present but two suites locked	Reinspect during estoppel collection

source note 3: Photo P-03 roofscupper staining; P-14 truck apron cracking; P-19 life-safety access.

System	Field Severity	Immediate Action	Seller Evidence Needed	Cost Bucket
Life Safety	localized	confirm extinguisher tags and emergency lights	locked-suite access	\$37,600.00
Roof	moderate	inspect scuppers and patched membrane after rain	roof warranty, leak log	\$209,000.00
Paving	moderate	price sealcoat, crack fill and truck apron repair	prior sealcoat invoice	\$132,000.00
HVAC	mixed	collect unit-level age and service records	seller maintenance schedule	\$121,000.00
